**Docket No. 217 – Development and Management Plan Inspection**

Northeast Utilities Service Company Certificate of Environmental Compatibility and Public Need for the construction of a 345-kV electric transmission line and reconstruction of an existing 115-kV electric transmission line between Connecticut Light and Power Company's Plumtree Substation in Bethel, through the towns of Redding, Weston, and Wilton, and to the Norwalk Substation in Norwalk, Connecticut.

**Date:** September 13, 2006

**Location:** Overhead Line (Composite 345kV and 115kV Gallows Hill to Archers Lane, 345kV H-Frame Hoyts Hill to Gallows Hill, and Norwalk Section)

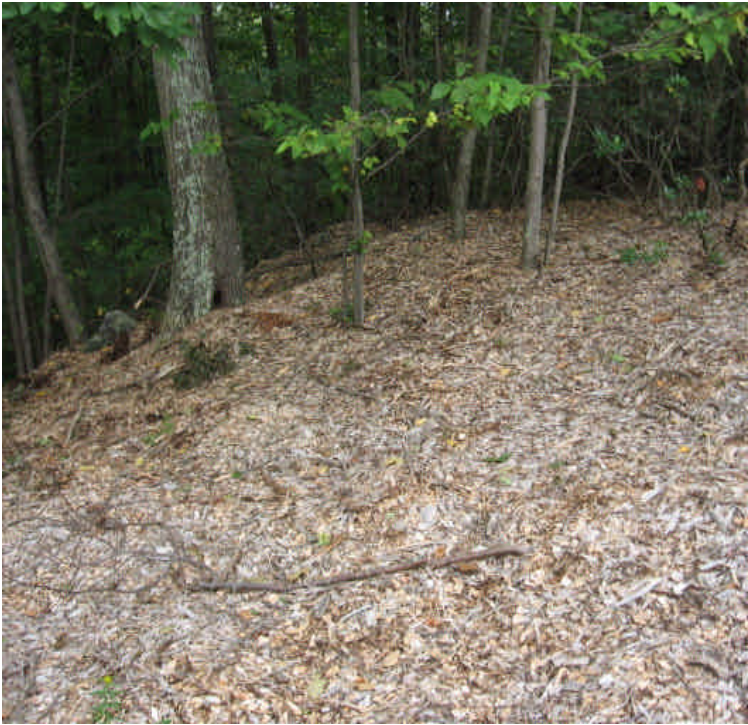
**(Composite Section):** Photo on the left shows the large pile of wood chips remaining in the ROW past Archers Lane between structures #43-44. Photo on the right shows a view of the third wetland crossing. A meeting was held this week to discuss restoration efforts. 9/13/06.

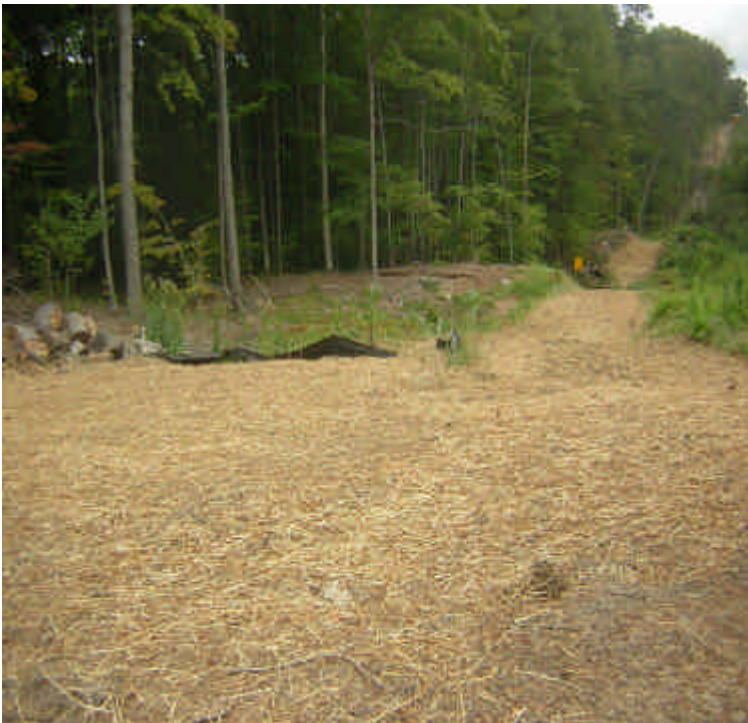
**(345kV H-Frame):** Photo on the left shows the area near structure #11 where the stockpile was removed and hay and seed was applied. Photo on the right shows a portion of the restored area at structure #10 where vehicle tracks were noted. 9/13/06.

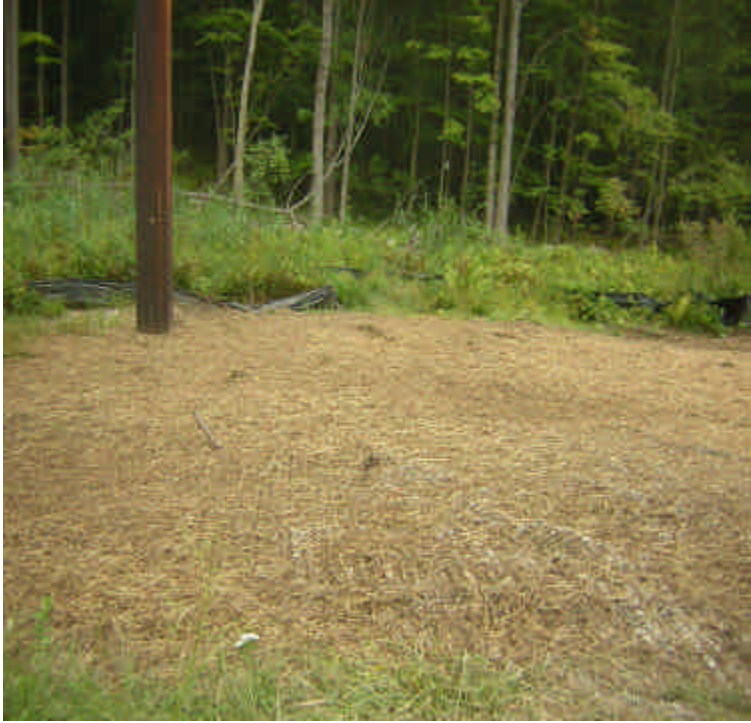
**Photo on the right shows the restored area at structure #6 in the ROW off Chestnut Ridge Road. The stockpile has been completely removed. Photo on the left shows a view of the restoration efforts along the ROW for this section. 9/13/06.**

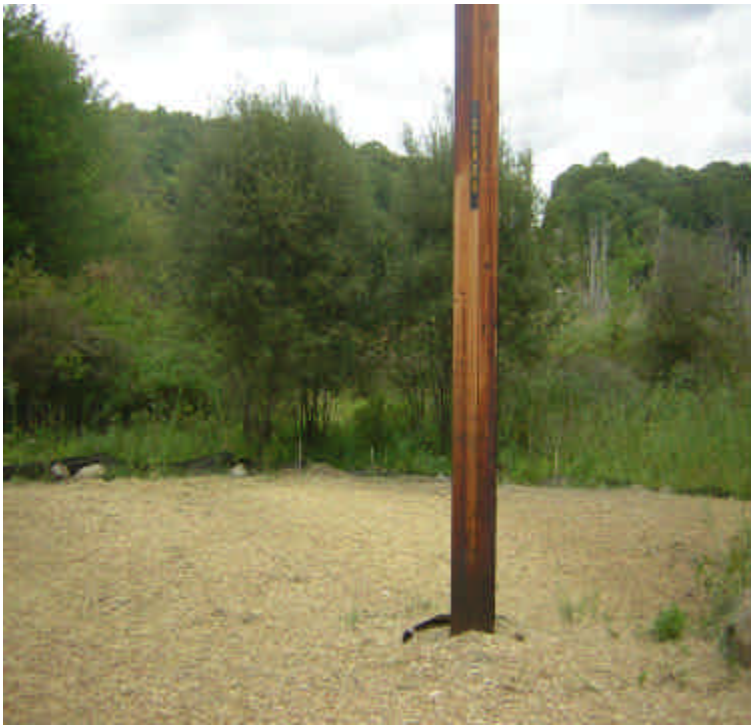
**Photo on the left shows the restored area near structure #25 off Lime Kiln Road. Photo on the right shows Reese applying seed and hay mulch near structure #23 off John Todd Way. 9/13/06.**

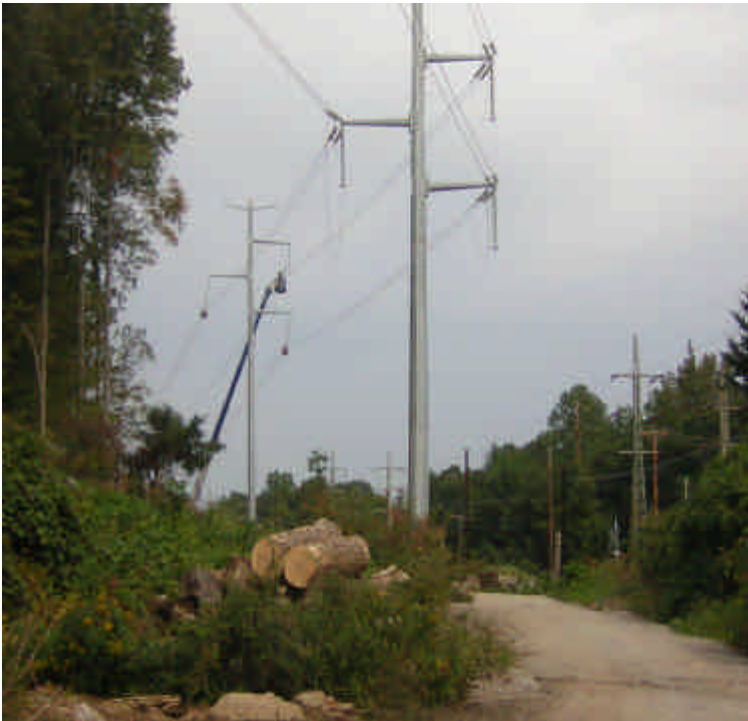
Photo on the left shows crews clipping wire at Kent Road (south). Photo on the right shows the erosion controls along the access road at Kent Road (south). Hay bales remain in place but some stone remains within the wetlands. 9/13/06.

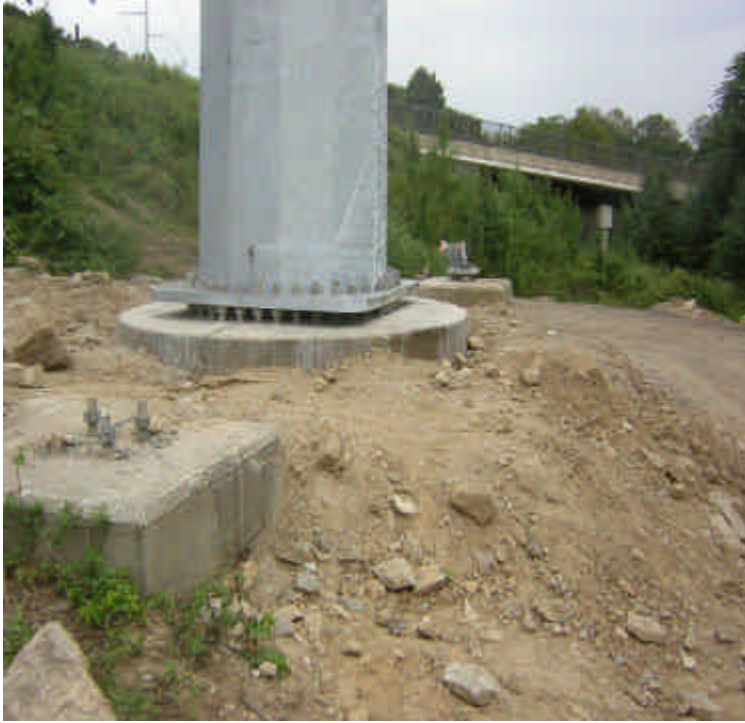
**Photo on the left shows a view of the old foundations remaining near structure #11063. Photo on the right shows crews removing old foundations near structure #11064. 9/13/06.**

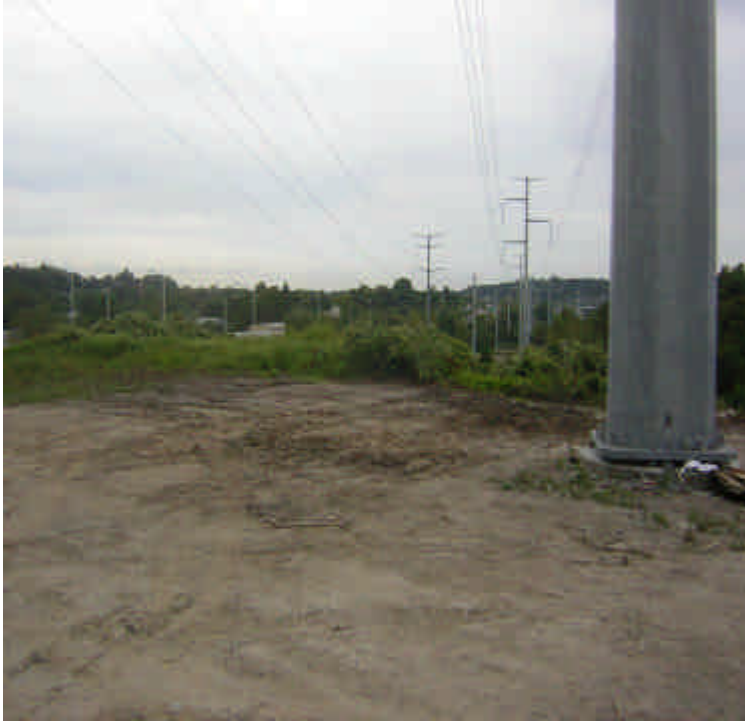
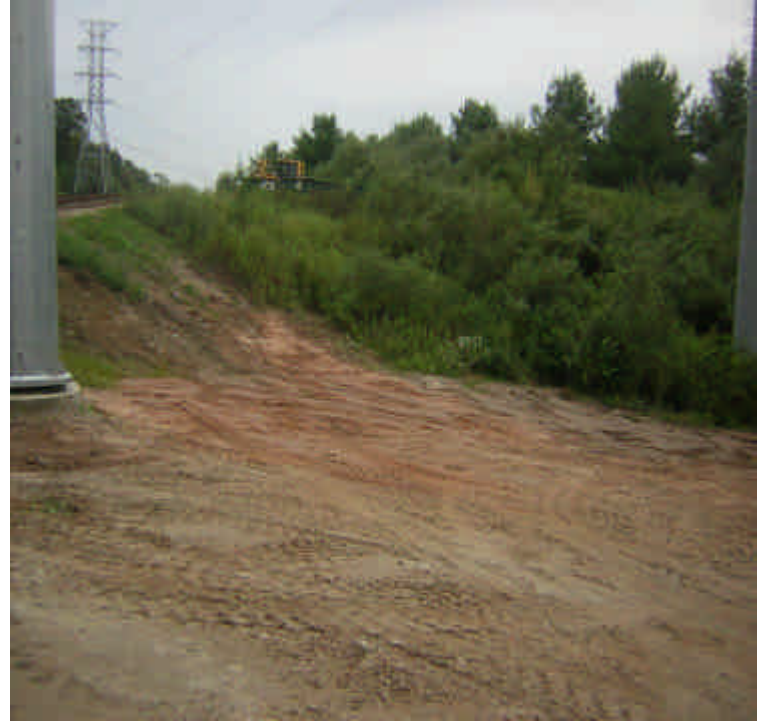
**Both photos show recently graded areas in the ROW off Perry Ave (left) and North Seir Hill Road (right). These areas have not yet been graded. 9/13/06.**
